GBON National Gap Analysis

Uganda

Screening of the National Gap Analysis (NGA) of Uganda

GBON National Gap Analysis Report UGANDA

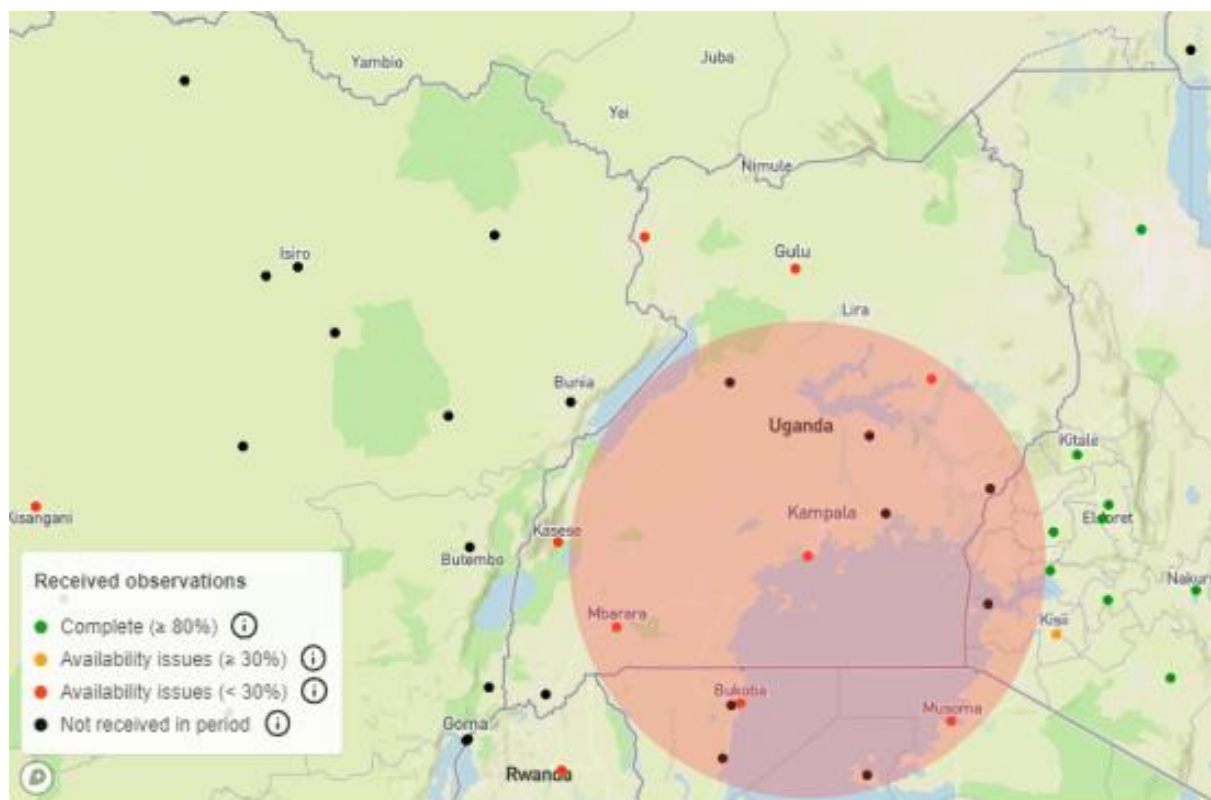
UNMA has no operational upper air station registered in WIGOS or at the WDQMS. The present Upper Air Station is located at Entebbe International Airport (Figure 4) and is inactive since 2017. Although station site and housing have recently been rehabilitated in 2023 (GoU funded), the station does not function due to failure of an obsolete Hydrogen generator, awaiting immediate replacement. Balloons and radio- sondes are in stock but are possibly in the vicinity of the expiry dates. Computer facilities (hard- and software) are lacking or are severely outdated.

Figure 4: There are no registered Upper Air Stations (UAS) in Uganda indicated in WDQMS. An UAS at Entebbe International Airport is inactive and requires rehabilitation. The red circles indicate the 500 km diameter coverage areas. Source map: WDQMS.

The UAS at Entebbe International Airport should be registered in WIGOS once it is again in operation. The existing (but non-functional) UAS, operated from Entebbe International Airport will cover approximately 55-60 % of the country, including most of Lake Victoria (Figure 6). A second station will increase the coverage, for instance when this is located at Lira (Doppler Radar site) or Gulu (WIGOS registered AWS) (Figure 6). The rehabilitation of the existing station is considered the first priority.

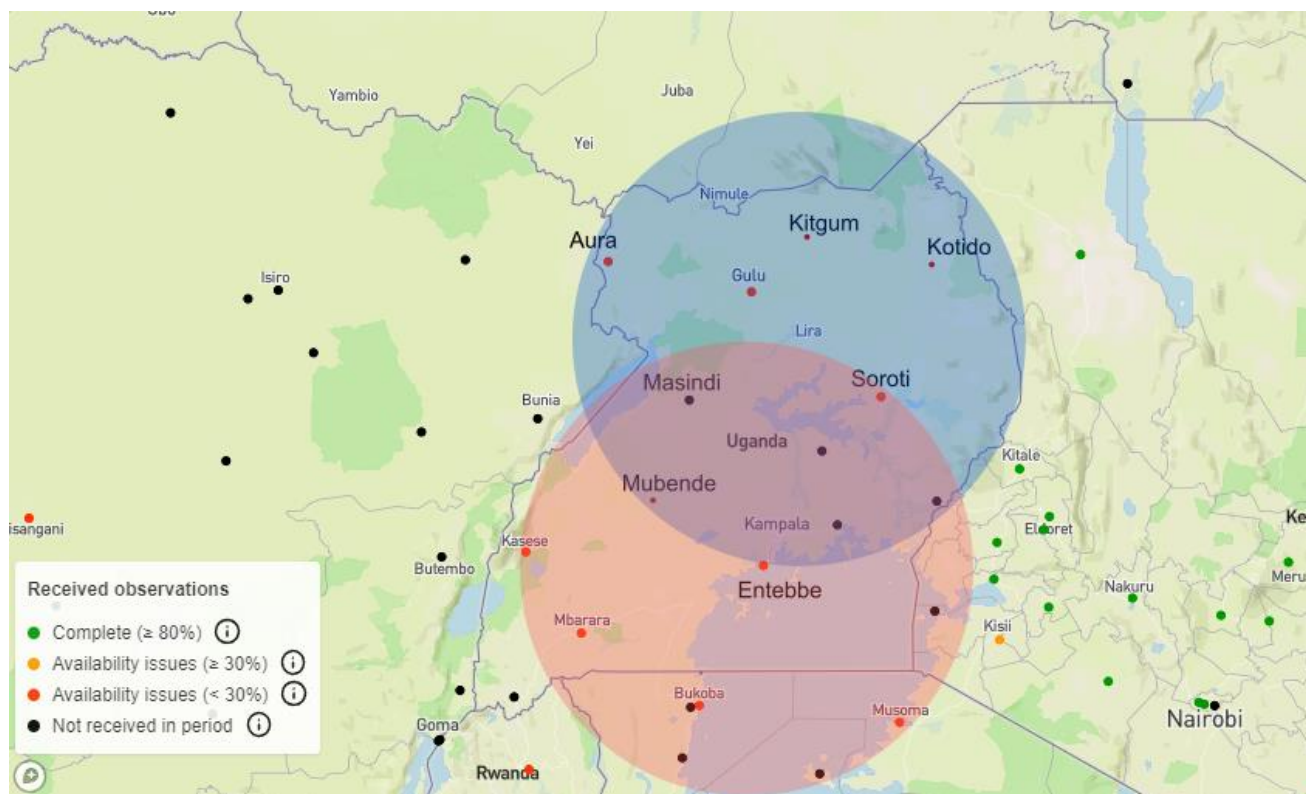
Figure 6. There are no registered Upper Air Stations (UAS) in Uganda registered in WDQMS. The circles indicate the 500 km diameter coverage areas. The UAS at Entebbe International Airport is inactive and requires rehabilitation (red). A newly proposed station at Lira (an existing radar site) is indicated, representing optimal coverage (blue). Gulu (northwest of Lira) is an alternative location. Source map: WDQMS.

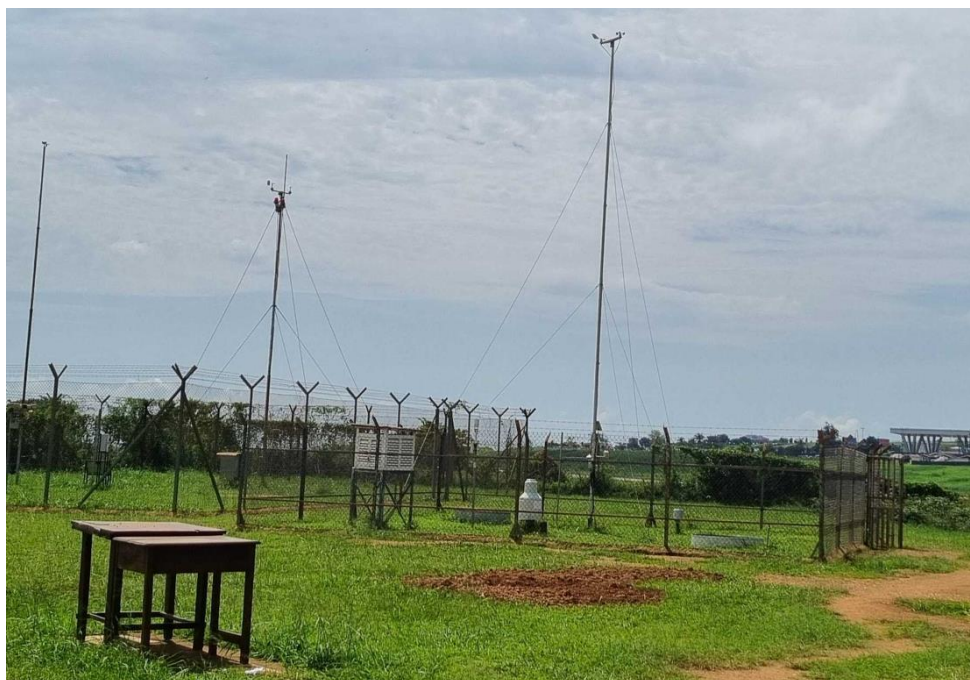
7 and Figure 88). Additional information for the nine (9) proposed stations was obtained via questionnaire on the status of station infrastructure and communications. The current stations transmitting data to GTS and the three (3) newly proposed GBON affiliated stations are not compliant with GBON standards. All nine (9) stations (including the 3 stations new to GBON) require major updates and rehabilitation in the coming 2-3 years taking into account the 10 year end of life cycle of the sensors and dataloggers.

Calibration efforts are minimal. Manufacturer maintenance plans cannot be executed. Data collection (data logger) technology in general is moderate. Software availability and internet connection for data transfer are poor or not existing. UNMA capacity for station maintenance is generally moderate, with lack of capacity, spares, calibration possibilities and financial resources being the main obstacles.

Figure 7: Existing and representative surface AWS located at Entebbe International Airport.

- Replacing of the nine (9) AWS dataloggers compliant with GBON equipped with the possibility to transmit to the Global Transmission System (GTS) or WIS2 without human interference,
- Rehabilitation of the nine (9) AWS in 2025 – 2026,
- Revamping of the existing manually UAS at Entebbe by immediately replacing the hydrogen generator and computer hard- and software, and
