GBON National Gap Analysis

Uganda

Screening of the National Gap Analysis (NGA) of Uganda

GBON National Gap Analysis Report UGANDA

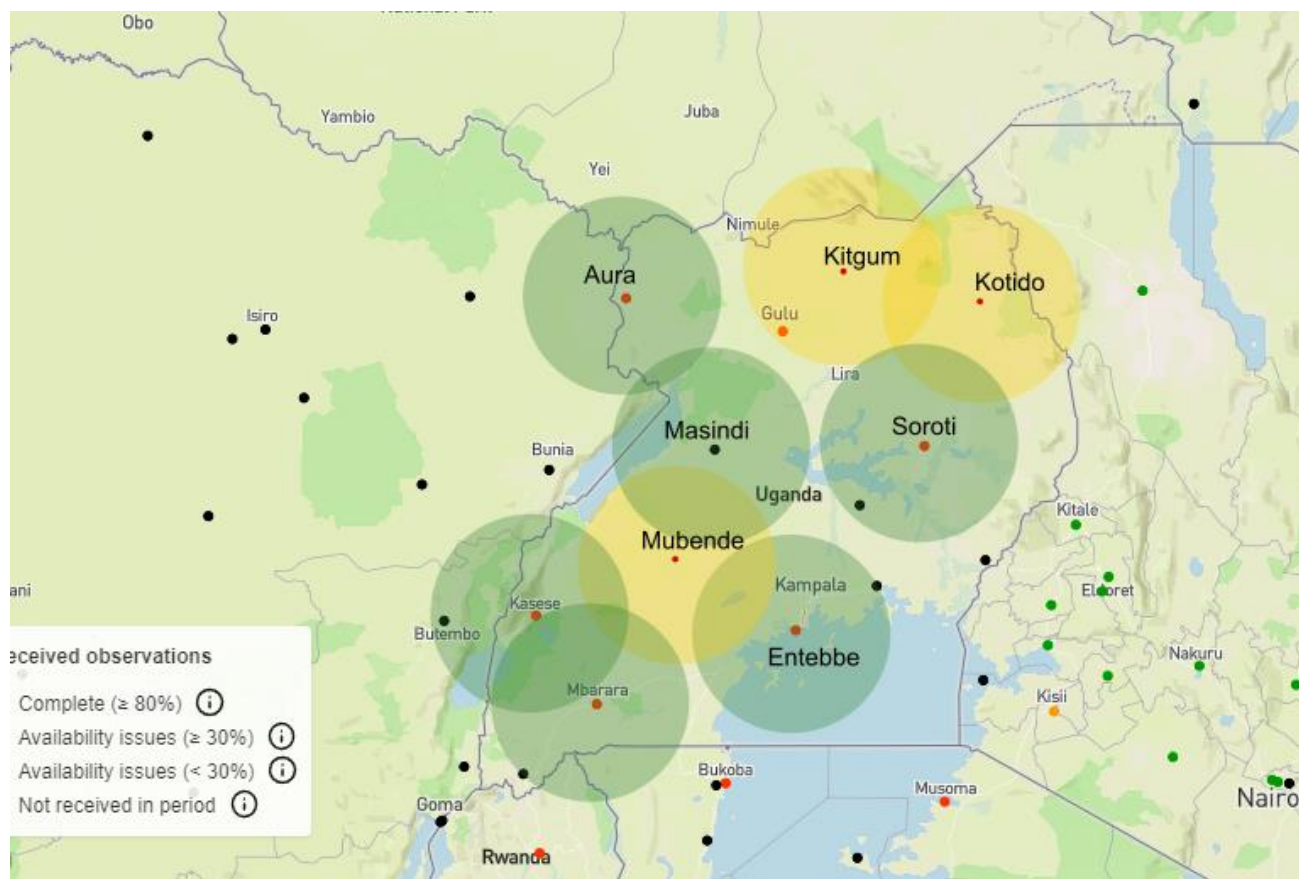
Three (3) additional GBON surface stations may close remaining spatial gaps in the central-west (Mubende) and north-western sections (Kotido, Kitgum) of Uganda. Those stations are indicated with yellow circles in Figure 5. These locations have functioning stations already, but are not yet registered in WIGOS or GBON affiliated. The proposed Kotido and Kitgum stations contribute to better representation of the dryer climate and rainfall distribution in the north-western region, which affect people their lives.

Figure 5: WDQMS registered surface stations to be included in SOFF for Uganda with diameter 200 km circles in green, including three new GBON affiliations for Kotido, Kitgum and Mubende in yellow. Source map: WDQMS.

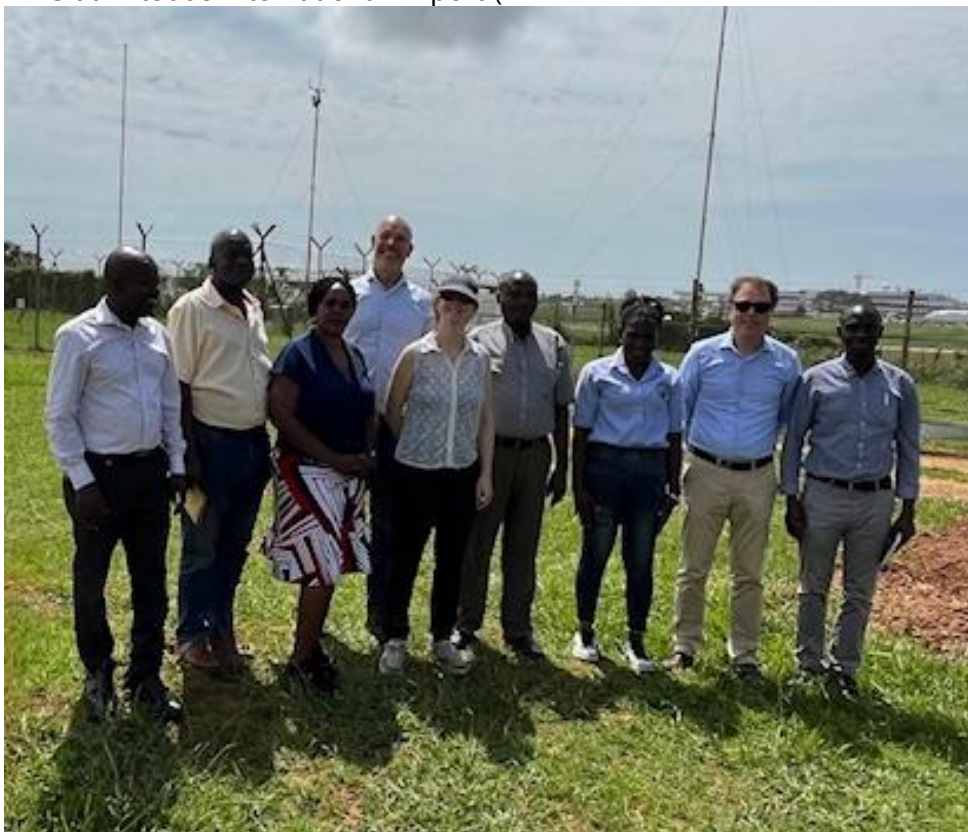
The UNMA – KNMI peer review delegation carried out a field mission to the primary synoptical AWS at Entebbe International Airport (

7 and Figure 88). Additional information for the nine (9) proposed stations was obtained via questionnaire on the status of station infrastructure and communications. The current stations transmitting data to GTS and the three (3) newly proposed GBON affiliated stations are not compliant with GBON standards. All nine (9) stations (including the 3 stations new to GBON) require major updates and rehabilitation in the coming 2-3 years taking into account the 10 year end of life cycle of the sensors and dataloggers.
